**Oregon State University
Engineers Without Borders
presents**

Post-Implementation Trip Report: A Rainwater Catchment and Storage System for Cerro Caballo

**Las Mercedes/El Naranjito, El Salvador
December 2008**

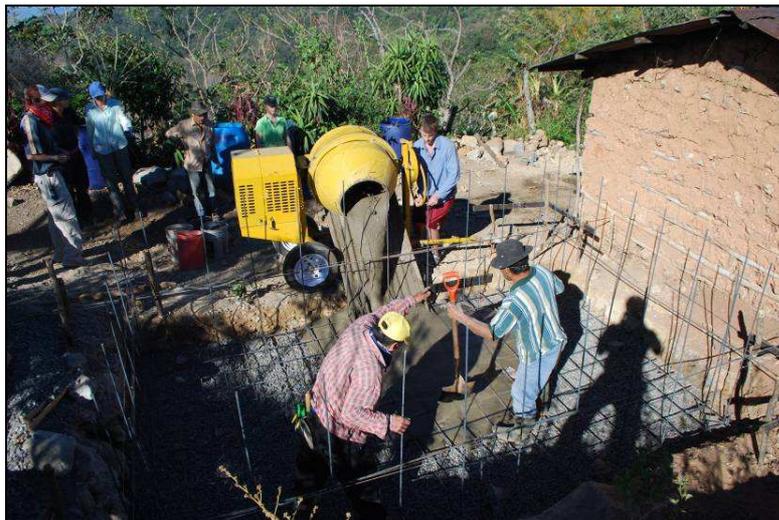
Figure 3.1: Pouring the foundation of Don Hugo's tank with the cement mixer. The rebar grid can also be seen.

To support such large tanks and the water inside them, the project team first built the foundation pads for each tank. Supported underneath by 6" of crushed angular 1/2" rock, the foundations were an additional 6" thick. Located 3" underneath the surface of the foundation was a grid of 3/8" rebar spaced 8" apart; see figure 1. The grid was situated to place a piece of rebar directly under the wall to allow for vertical rebar to tie into.

To ensure that the large foundations were properly poured in a timely manner, the team rented a gasoline-powered, portable cement mixer from the hardware store in Ahuachapan. The cement mixer was extremely helpful; with its help, the team was able to pour all three tank foundations in one day (see Figure 3.1).

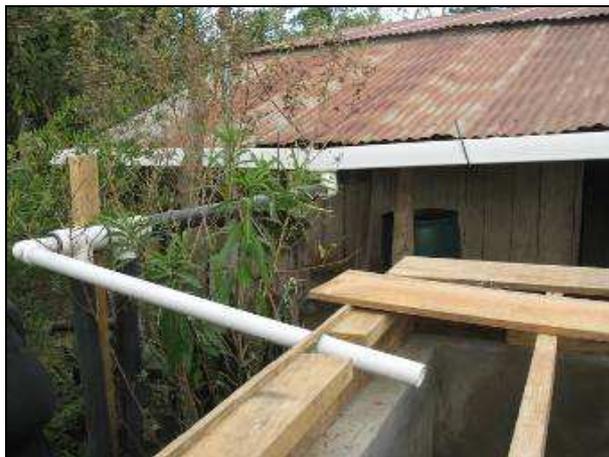
Figure 3.2: Gutters, first flush, and inlet to tank at Don Jesus's house, prior to the tank roof being completed.

Openings were placed in the tanks for water to enter and exit. An example of the tank inlet can be seen in Figure 3.2. The lowest opening was located about 3" from the base of the wall and the protruding pipe served as an attachment for a spigot. One other opening was placed in the top row of blocks to allow for an overflow pipe. This 2" diameter pipe will divert excess water into a drainage field when the tank is full. The drainage field for each tank consisted of buried PVC pipes with holes or slits cut into the side to allow the water to gradually diffuse over a large area.

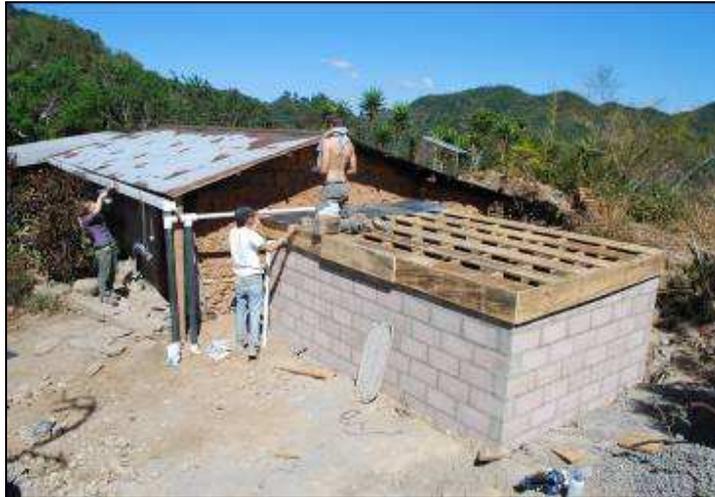
Figure 3.3: Don Hugo's tank and partially completed roof. Gutters and first flush also shown.

The tank roofs were constructed with a simple joist design, like a floor or ceiling, elevated at one end. It was framed to sit on top of the tank flush with the outside edges. Flat 1"x lumber was laid across the top to support the overlapping 3'x9' galvanized steel sheets used as roofing. These sheets overhung the edges of the roof by 1-2", where they were bent over and nailed to prevent water from getting underneath. More 1"x lumber was placed around the edges to fit over the tank walls and prevent the lid from moving. All significant gaps and the seams between each piece of galvanized steel were sealed with silicone caulk.

The roof construction can be seen in Figure 3.3. Community members were left with a gallon of waterproof, non-toxic, acrylic paint to cover the exposed wood around the edges of the tank to prevent splitting due to exposure to the weather.

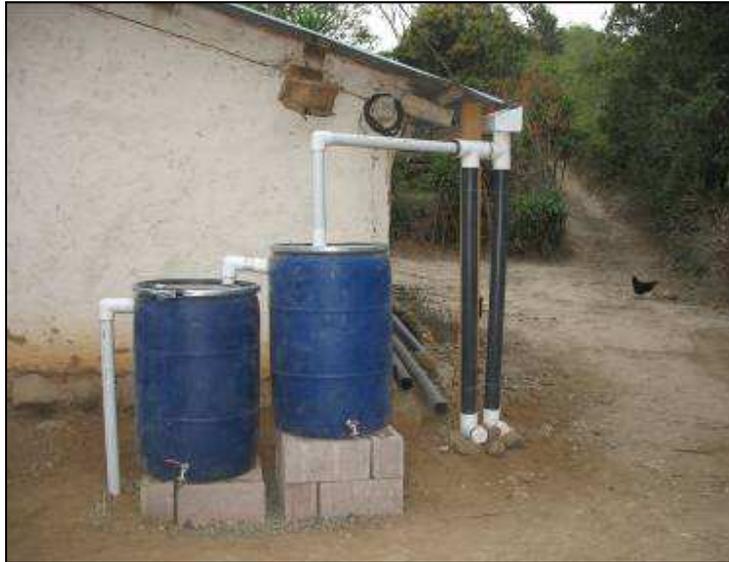
Figure 3.4: Setup of rain barrels at Don Jesus's house.

The barrels were constructed in a cascaded design such that the overflow from the first barrel filled the second barrel. The first barrel sat atop two layers of cinder blocks, while the second barrel sat beside it atop one layer of cinder blocks. The height difference allowed for the overflow pipe at the top of the outer face of the first barrel to feed directly into the top face of the second barrel, which also was open to the atmosphere. This setup can be seen in Figure 3.4.

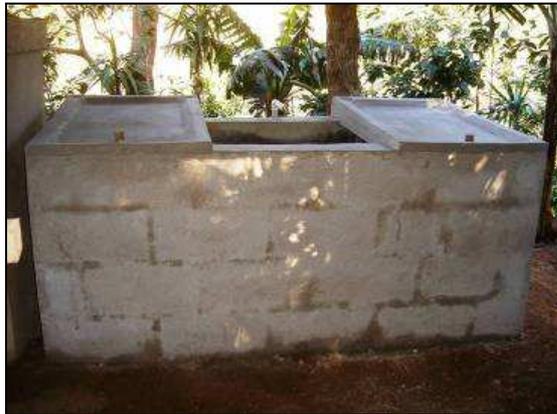
Figure 3.5: Wash station built by Don Pascual after the March 2008 trip

After the June 2008 trip, wash station materials were left at Don Pascual's home in Las Mercedes, with plans to build the wash station during the December 2008 trip. Upon arrival, the travelers found that Don Pascual had already built a very nice wash station with the provided materials, as can be seen in Figure 3.5.

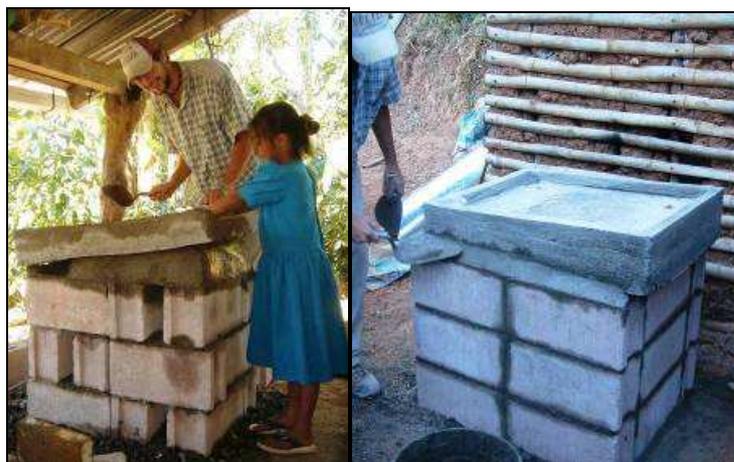
Figure 3.6: Wash stations at Don Jesus's house (left) and Don Manuel's house (right).

In Cerro Caballo, two wash stations were completed during this trip, one for the Don Jesus household and one for the Don Manuel household. The wash stations were constructed with cinder blocks and concrete, and two slightly different designs were implemented, and are pictured in Figure 3.6. At Don Jesus's house, proper drainage was best achieved using gravel under and surrounding the base of the wash station. At Don Manuel's house, the wash station was placed near the barrel system, allowing a PVC pipe from the wash station to tie into the barrel overflow drainage. The wash station was built on a concrete foundation. Both wash stations were topped with a concrete slab with ¼" rebar. Don Hugo, a skilled mason, preferred to receive the materials to build his own wash station rather than having the project team construct it for him.

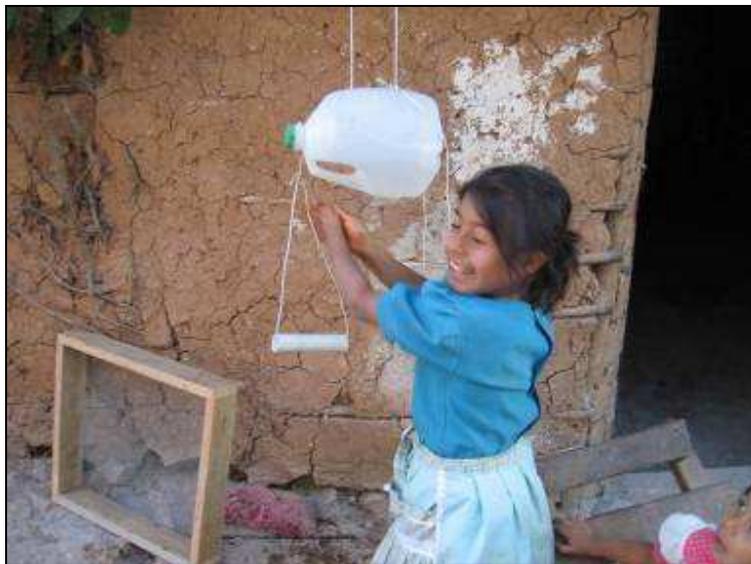
Figure 4.2: Tippy Tap use by children in Cerro Caballo.

In an attempt to encourage hand washing practices in the community, “tippy taps” were constructed for households in Cerro Caballo. The tippy taps were made from old, plastic containers that had been previously used to hold water and were set up as hand washing stations. These educational tools were easy to construct, used only a small amount of water to implement, and were fun for the children in the community, as can be seen in Figure 4.2. Small soap containers were also attached to the structure to encourage effective hand washing practices. Tippy taps were hung outside the door of dwellings for easy access.

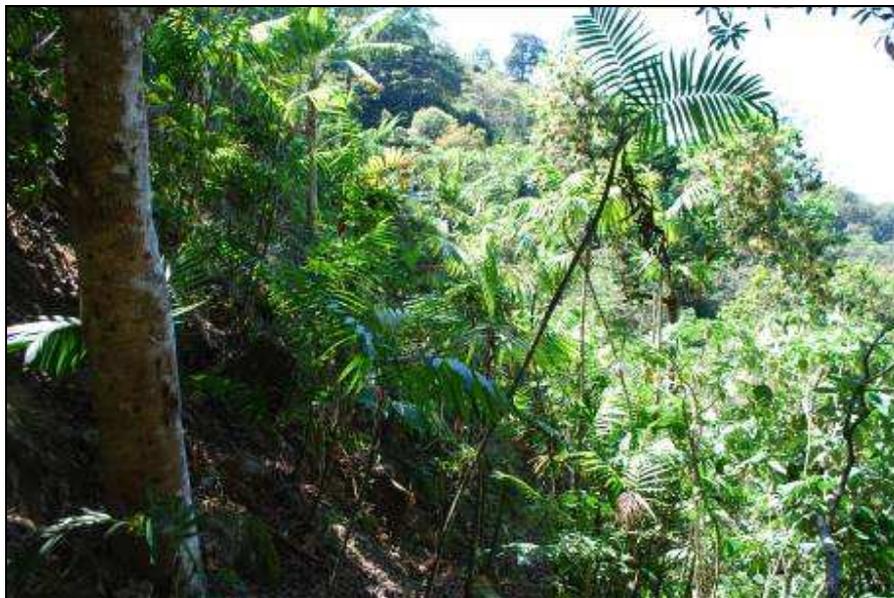
The terrain in this area was the harshest of the three sites surveyed, and would involve laying pipe from below Don Maximino's house in La Cumbre down to the community of Lower Las Mercedes. The path starts at the spring on a level ground before quickly dropping down about 15 meters. The route would then follow the contours of the ridge until reaching Lower Las Mercedes. For approximately the first 100 meters, the slope of the ridge is very steep and full of boulders, both of which cause concerns about difficulties laying the pipeline. The terrain can be seen in Figure 5.1.

Figure 5.1: The steep hillside near the spring for Lower Las Mercedes is a physical challenge to any potential pipeline.
