PROGRAM CLOSEOUT REPORT

CHAPTER: **Oregon State University**

COUNTRY: **El Salvador**

COMMUNITY: **Las Mercedes – El Naranjito**

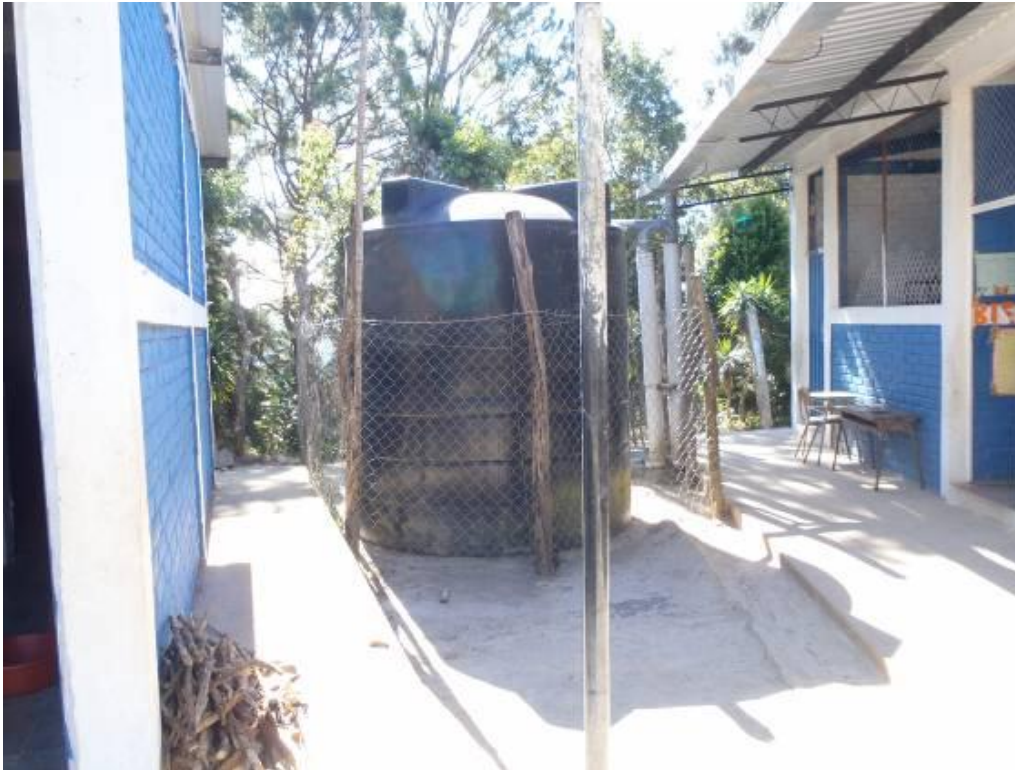
Two problems with the El Naranjito School system were identified during the final monitoring trip. First, the water in the tank was not being used for drinking as intended, and second, the left and right first flush system drain caps were respectively too difficult and too easy to remove. Instead of being used as drinking water, the water was used for washing dishes and cleaning the school. When asked why this was the case, the principle of the school said that the water was not clean enough to drink. EWB-OSU never planned on developing a method of water disinfection at the time of implementation. Rather, it was assumed that the first-flush system would be adequate to ensure proper water quality. Despite the fact that the system is not being used as intended, it is still saving time formerly used to haul water for washing.

Figure 2.2.1 Rainwater catchment tank at the El Naranjito School

The school head attended the meeting mentioned in section 2.1 and acknowledged the full transfer of responsibility of maintaining the rainwater catchment system at the El Naranjito School from EWB-OSU.

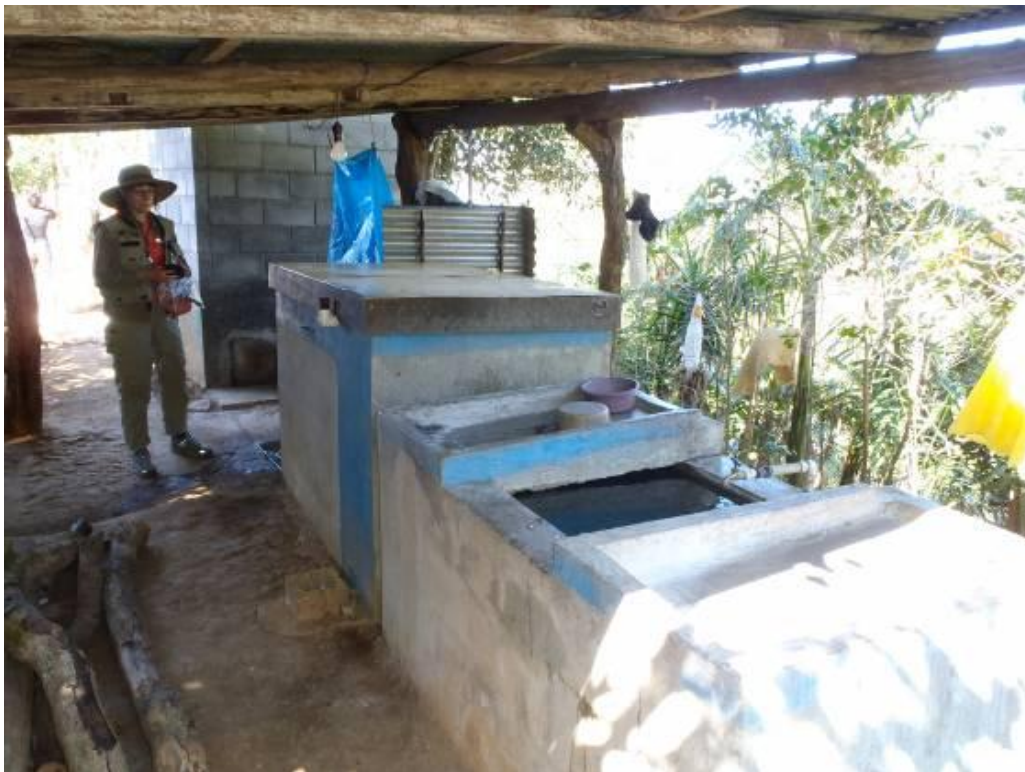
Figure 2.2.2 Water storage tank connected to the infiltration gallery in Las Mercedes

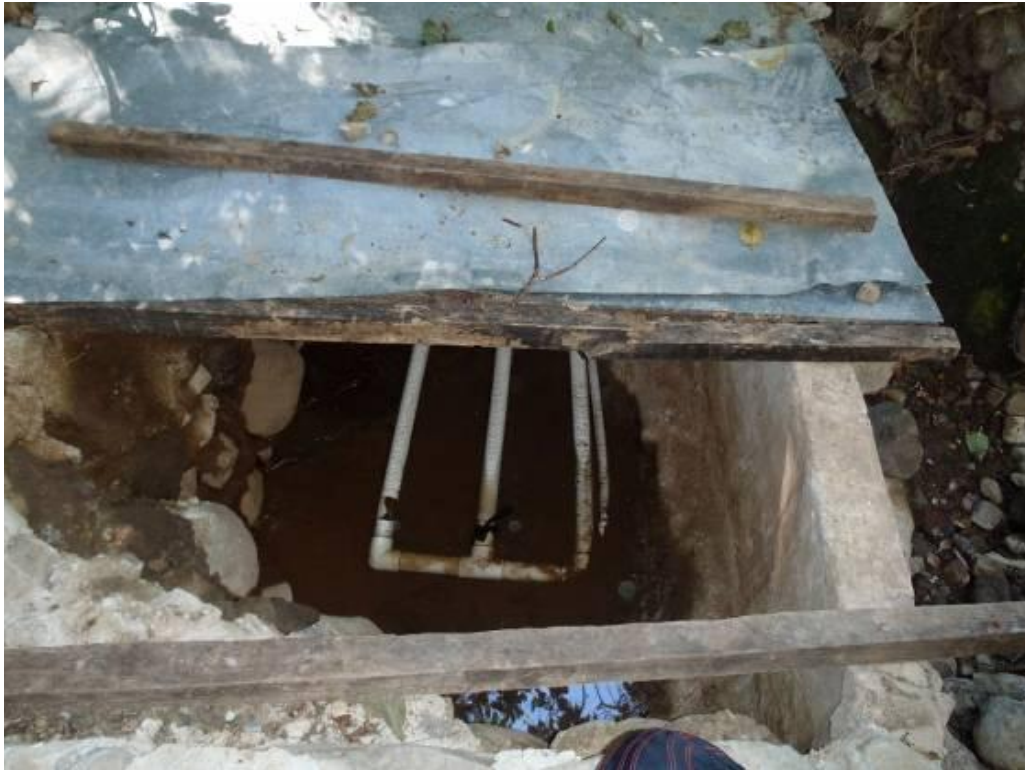
The gravity fed infiltration gallery system in Las Mercedes was partially damaged at the time of visit in March 2011 (see figure 2.2.3). Although the spring water was reaching the intended households, the infiltration gallery had been excavated by community members as they had experienced excessive amounts of sand clogging the pipe line. The cause of the excessive amount of sediment flowing through the system was not identified definitively, although EWB-OSU travelers suspect vandalism as a possible explanation.

During conversations with community members, EWB-OSU learned that some community members thought the sand covering the perforated pipes were contaminating the system. However, the system was designed and constructed to keep sand from entering the pipe system. During the installation of the system, water from the source flowed freely through the pipe system and sand was not observed in the water collected at the beneficiaries' households. In addition, when the filtration system was tested by large tropical storms after the infiltration portion of the system was built and the pipeline was still being installed, the water flowing from the pipelines was clear during and after the storm events. EWB-OSU made efforts to explain this idea to the community members.

Figure 2.2.3 Excavated infiltration gallery in Las Mercedes

The beneficiaries of the system attended the community meeting mentioned in section 2.1, and acknowledged the full transfer of the responsibilities required to maintain this system.

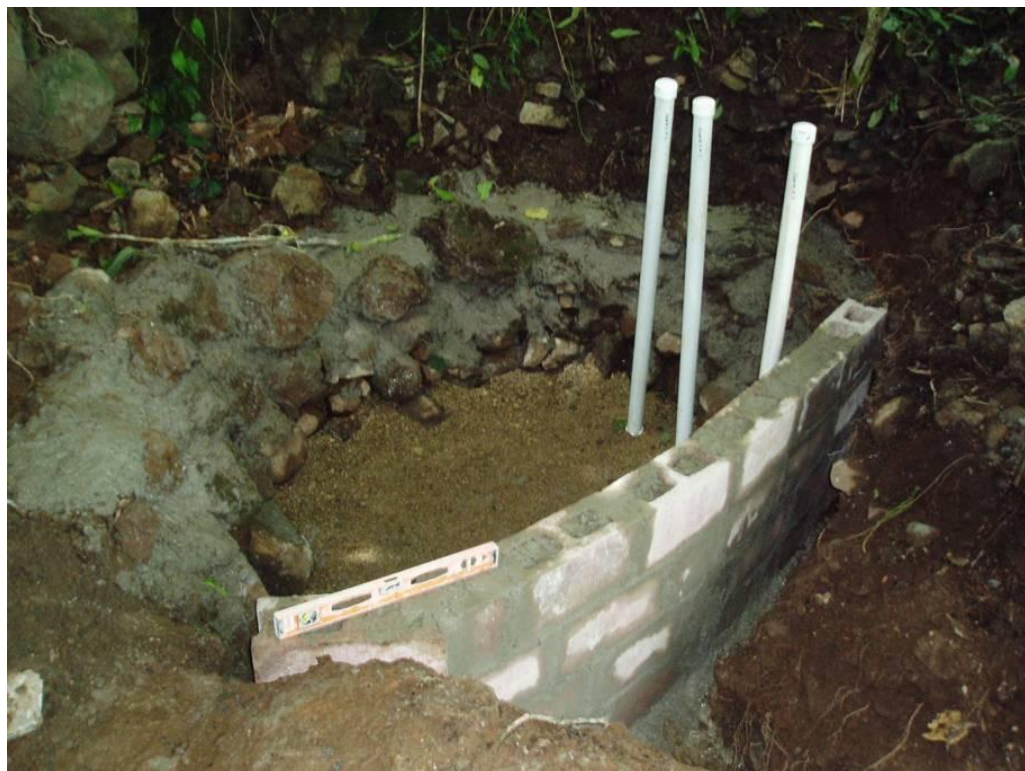
Figure 2.2.4 Infiltration gallery during the installation in December 2008

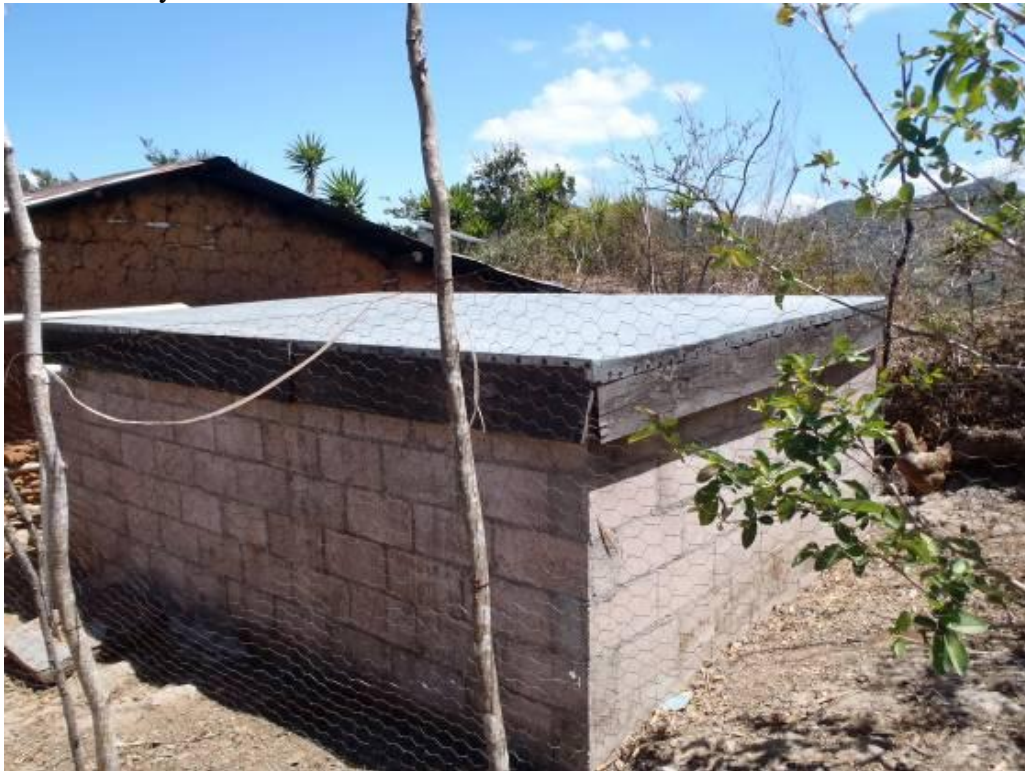
At the time of visit, Don Hugo and Don Manuel were not at their households. Don Manuel had moved to a different part of the community hence his system was not in use. EWB-OSU was only able to visit with Don Jesus. Don Jesus used the water stored in his tank for farming purposes. The gutters of the system had been temporarily removed by Don Jesus to prevent vandalism and dust accumulation on the surface of the gutter. During the visit, he pointed out several inconvenient design flaws in the system, such as the width of the collection point which is too small to fit the 20L water jug that is commonly used in the community. However, no further improvements were done because the flaws were minor, the system was not heavily used, and there was no initiation from the beneficiary.

Figure 2.2.4 Don Hugo's rainwater catchment system

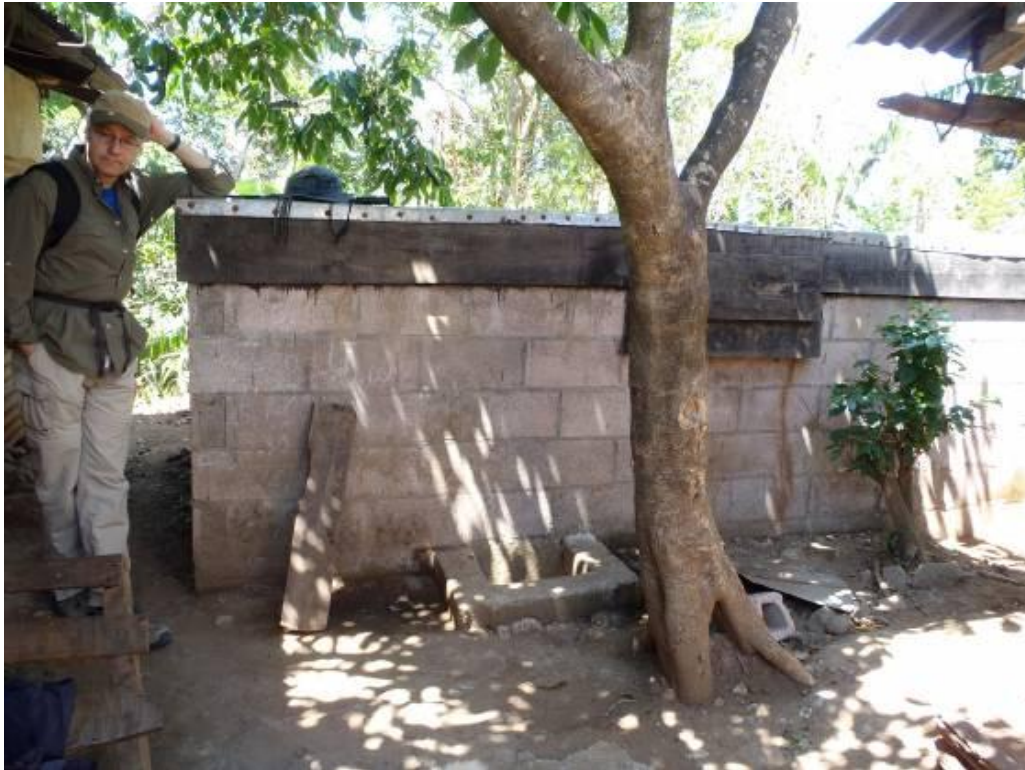
Figure 2.2.5 Don Jesus' rainwater catchment system

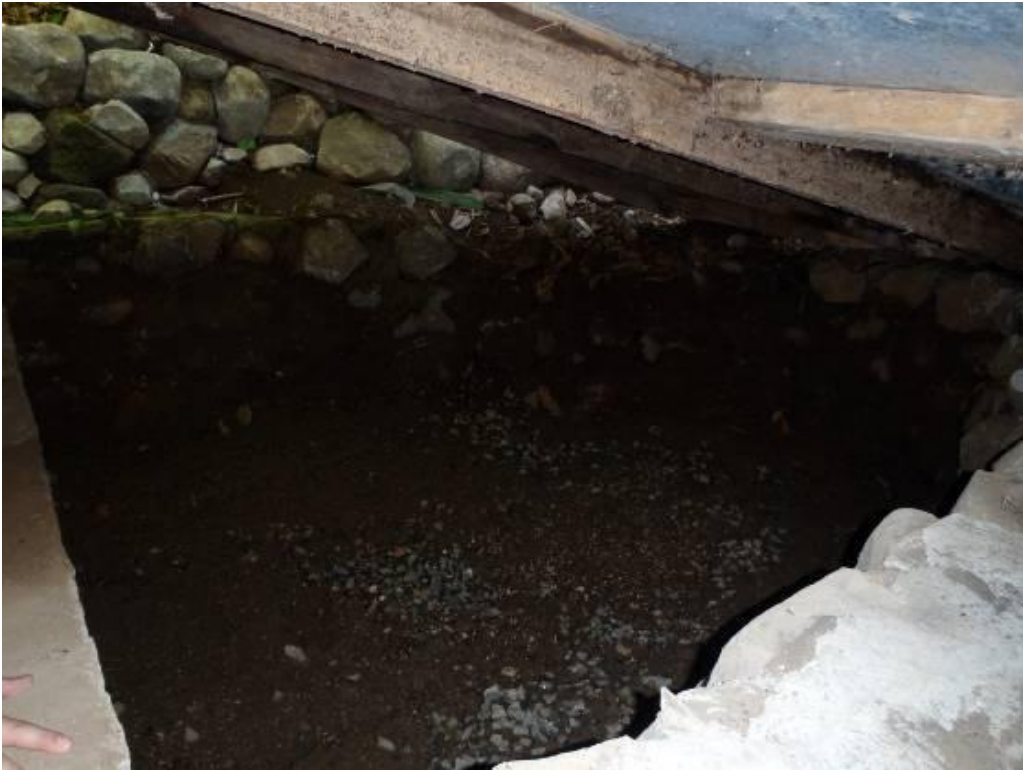
At the time of the final monitoring trip the storage tank connected to La Cumbre gravity fed infiltration gallery had dried up since the beginning of March. This was partly due to the dry season, but also due to leakage along the edges of the infiltration gallery's downhill retention wall. After inspecting the system and determining the source of the leakage, materials were purchased by EWB-OSU for repair. The purchased materials were left with the community water board. The plan for repairing the system was explained to Don Maximino who is the community leader and direct beneficiary of the system.

Figure 2.2.5 Inside the infiltration gallery in La Cumbre

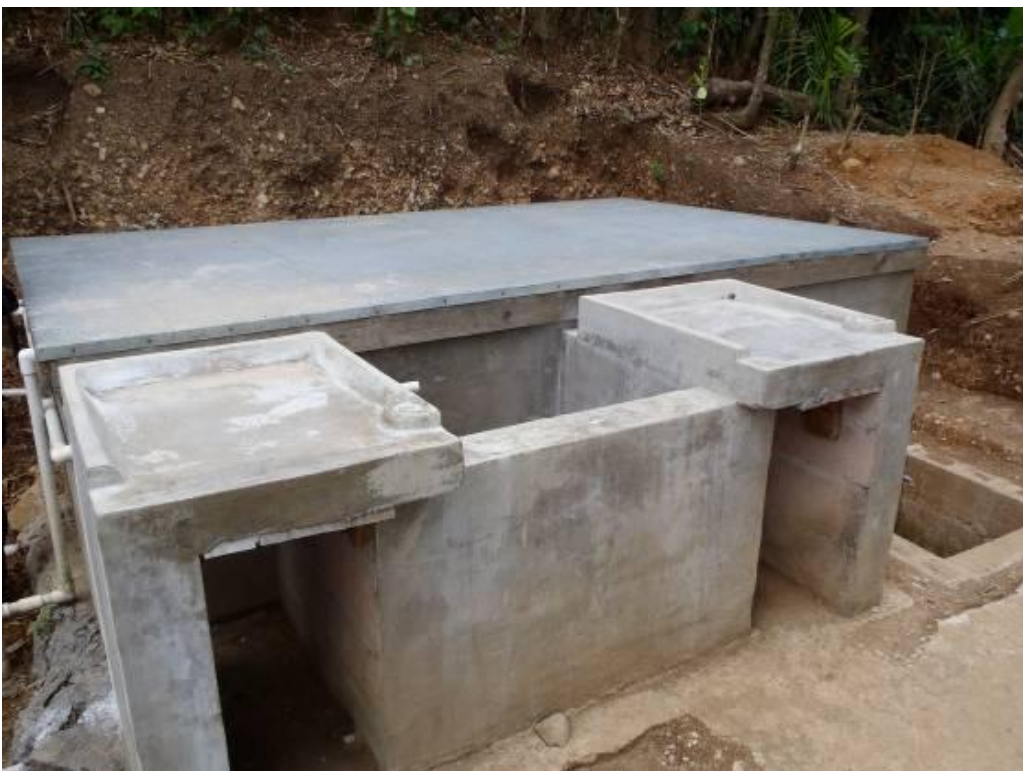
The elevation of the storage tank relative to the diversion point was also identified as a problem. Due to the small elevation head presence between the water source and the collection point, during the rainy season, water level in the infiltration gallery does not increase enough to fill the storage tank. In addition, the wash stations were not being used, because all of the people who live below the storage tank have pipelines running from the tank to their homes. Thus, they do their laundry at home rather than carrying it to the tank.

Figure 2.2.6 Water storage tank connected to the infiltration gallery

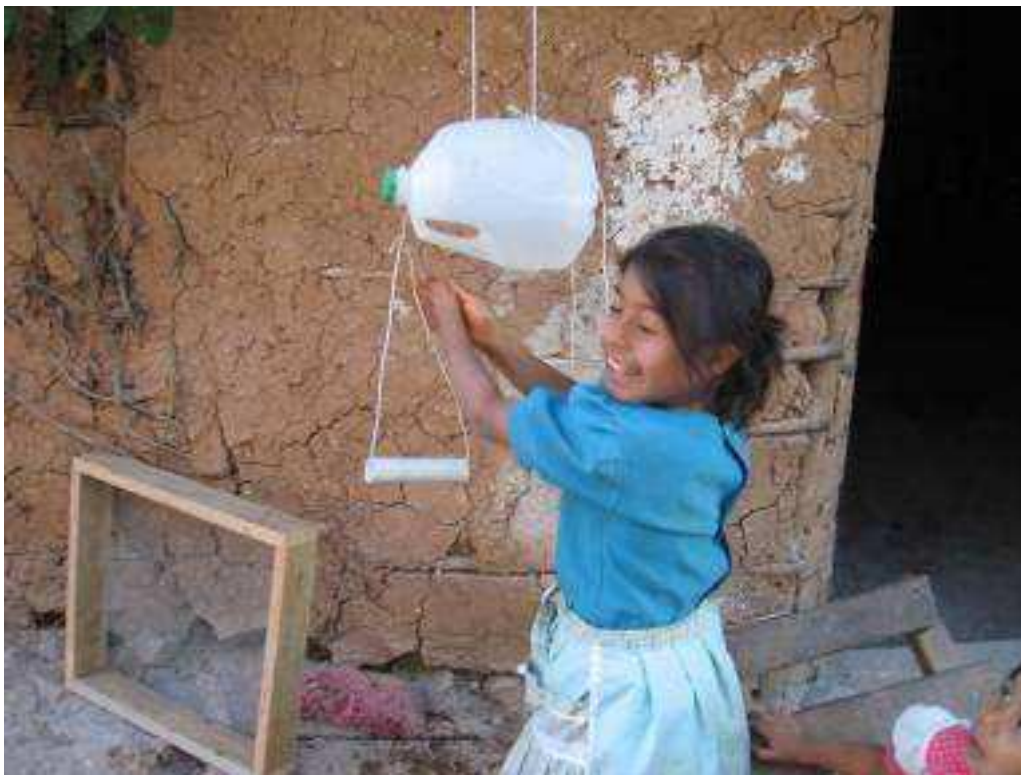
In an attempt to encourage hand washing practices in the community, “tippy taps” were constructed for households in Cerro Caballo. The tippy taps were made from old, plastic containers that had been previously used to hold water and were set up as hand washing stations. These educational tools were easy to construct, used only a small amount of water to implement, and were fun for the children in the community, as can be seen in Figure 4.2. Small soap containers were also attached to the structure to encourage effective hand washing practices. Tippy taps were hung outside the door of dwellings for easy access.

Figure 4.2: Tippy Tap used by children in Cerro Caballo.
